# TLS-450<sup>PLUS</sup> Consoles

## Troubleshooting Guide

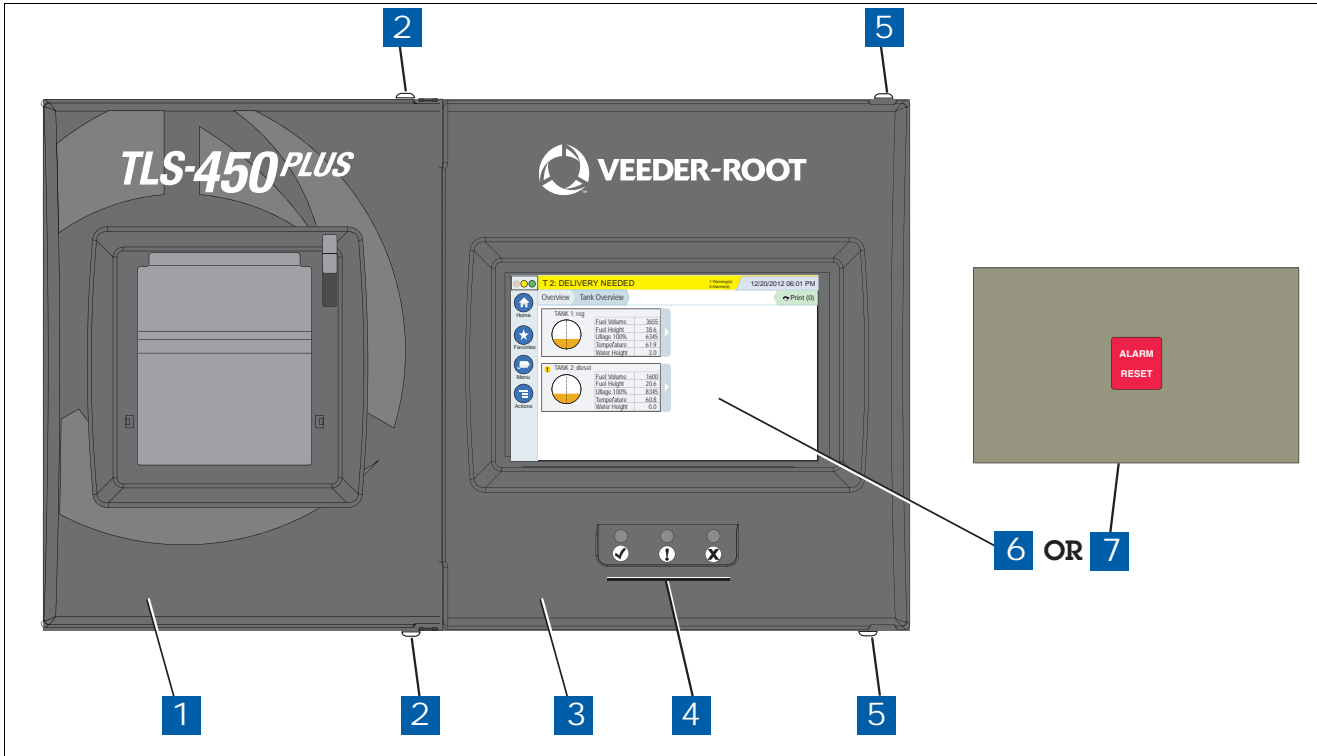
Figure 2-1. Console Front Panel

Legend For Figure 2-1			
Item	Description	Item	Description
1	Left door (showing optional printer)	6	Optional Graphical User Interface (GUI) touch display
2/5	T-15 Torx screws, remove to open doors and access system components	7	Acknowledge (ACK) Switch panel
3	Right door		
4	LED Status indicators: ✓ System Normal (Green); ✘ Warning (Yellow); ! Alarm (Red)

1. Remove the both left and right door screws and swing doors open to the left (see items 2/5 in Figure 2-1).
2. For the Ack Switch panel door remove the Ack Switch Panel cable plug from its CPU board connector (item 16 in Figure 2-11 on page 2-10).

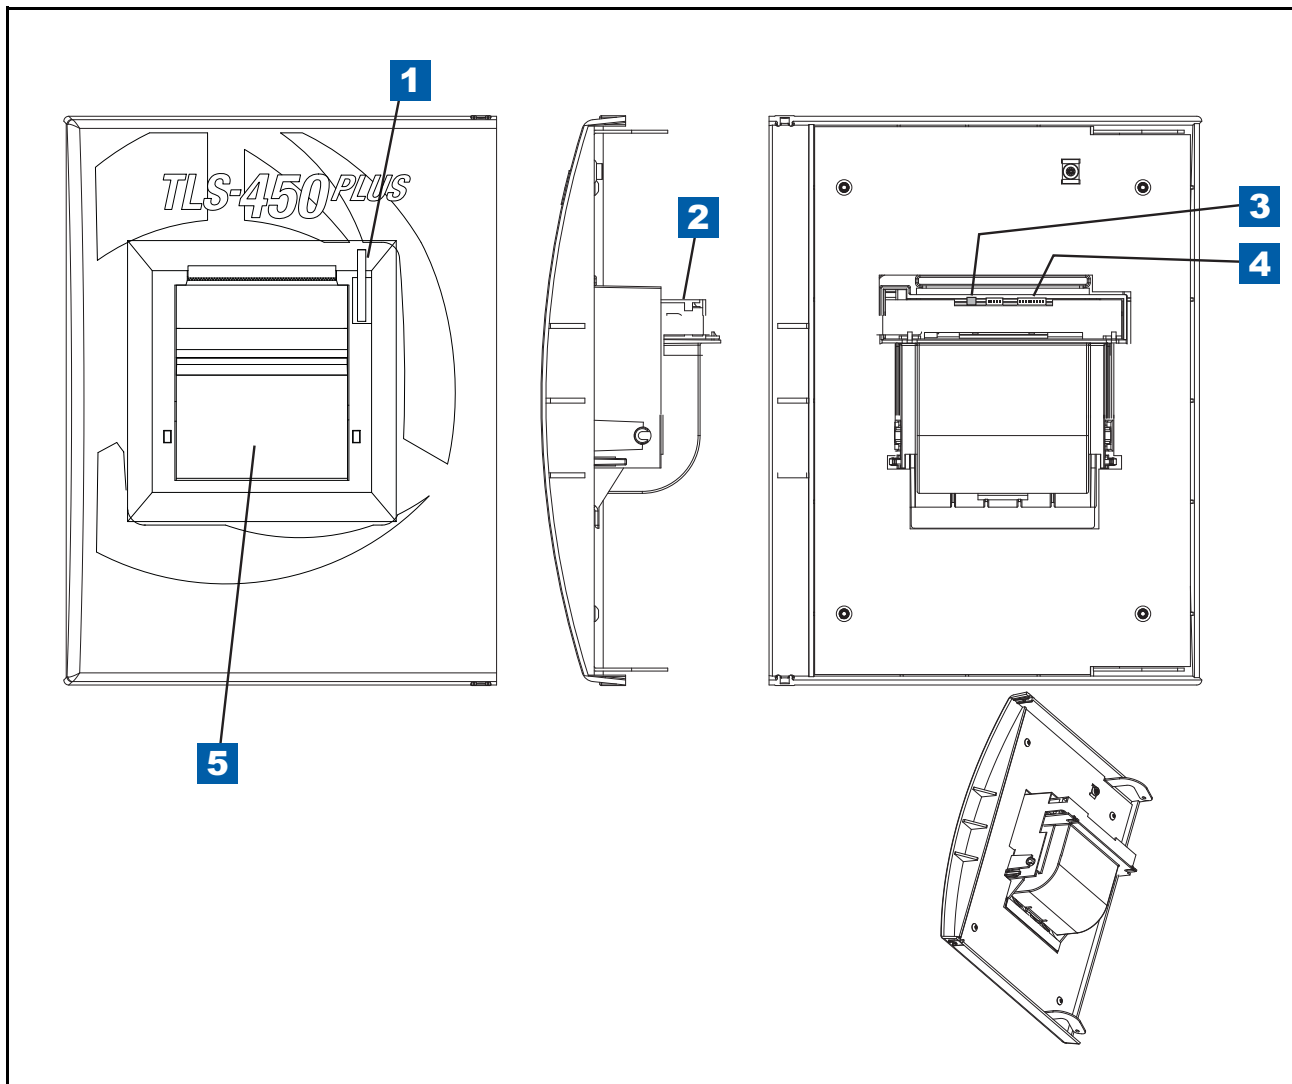
Figure 2-2. Printer Door Assembly

Legend For Figure 2-2			
Item	Description	Item	Description
1	Paper roll release lever	4	Connector for data input cable to USB1 on CPU board
2	Printer assembly	5	Paper cover
3	Connector for power input cable to J1 on Power Supply board

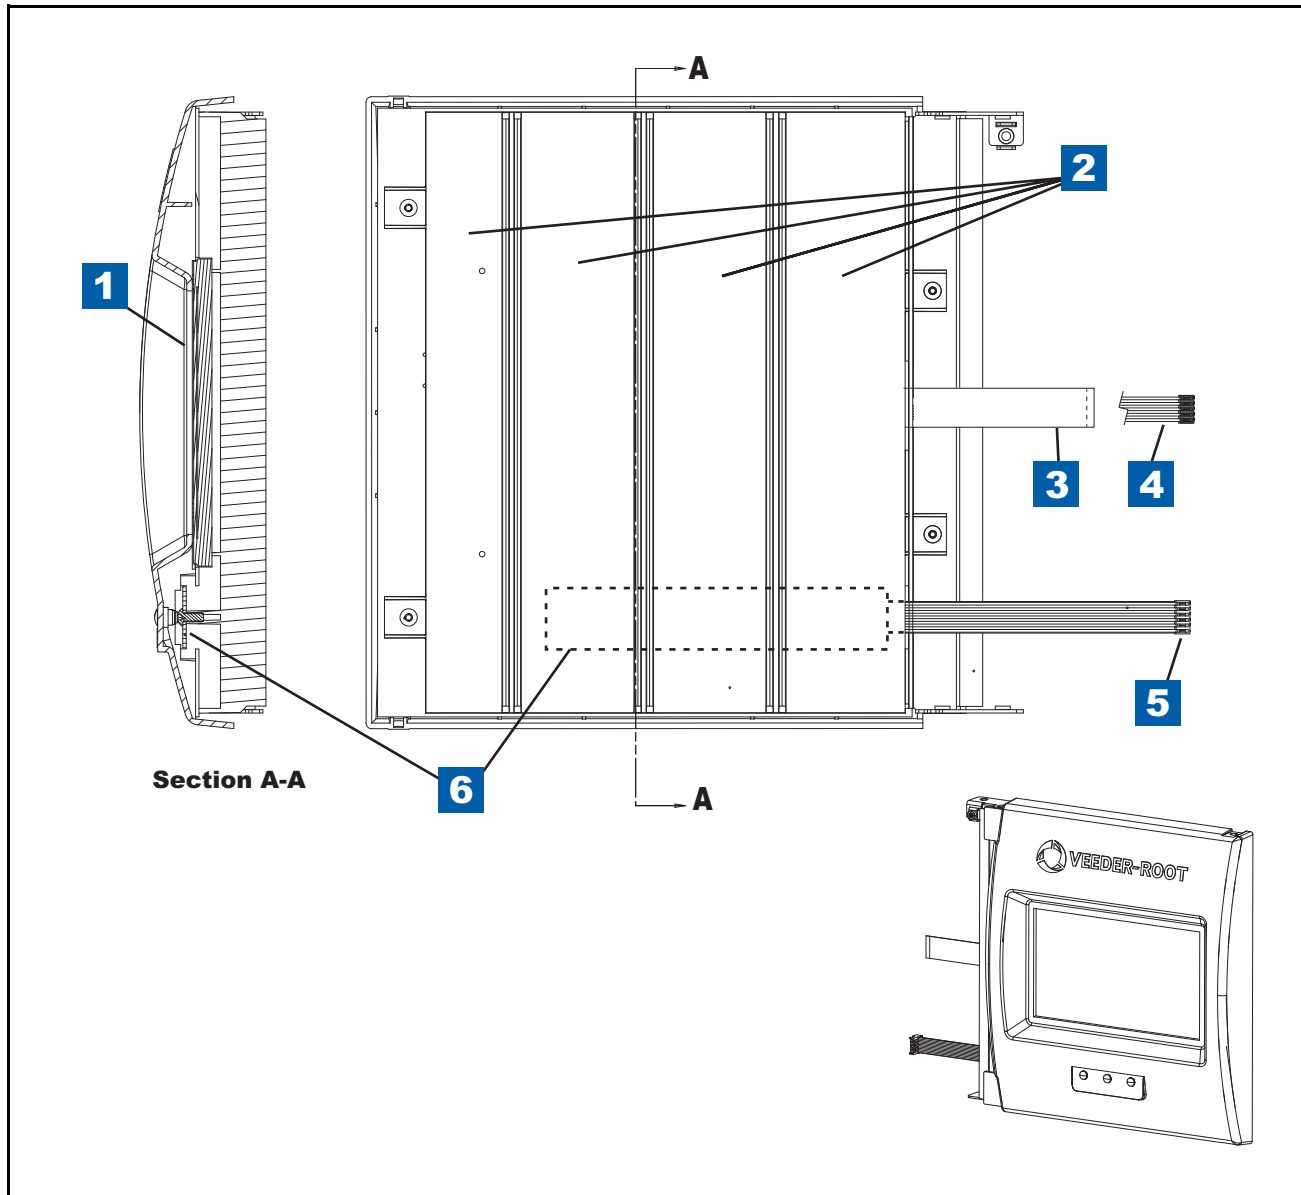
Figure 2-3. Display Door Assembly

Legend For Figure 2-3			
Item	Description	Item	Description
1	Touch screen display assembly	4	Cable to Ack Switch Panel connector on CPU board (item 16 in Figure 2-11)
2	Input Module Connection Labels	5	Cable to LED Backlight connector on CPU board (item 11 in Figure 2-11)
3	Cable to Data Display connector on CPU board (item 6 in Figure 2-11). Data Display is an option.	6	Front panel system status LED board assembly

Symptom	Cause	Corrective Action
<b>Display Dark After Boot-Up</b>	Bad Display cable, loose Display cable.	<p>1. Open the printer door.</p> <p>2. Verify the Display ribbon cable (Item 3 in Figure 2-3 on page 2-3) is securely seated in its CPU board connector and that the locking latch (1 pointer) is down against the cable. If inserted fully, the blue end of the cable will be no more than 1/16" (2mm) out of the connector as shown below:</p>

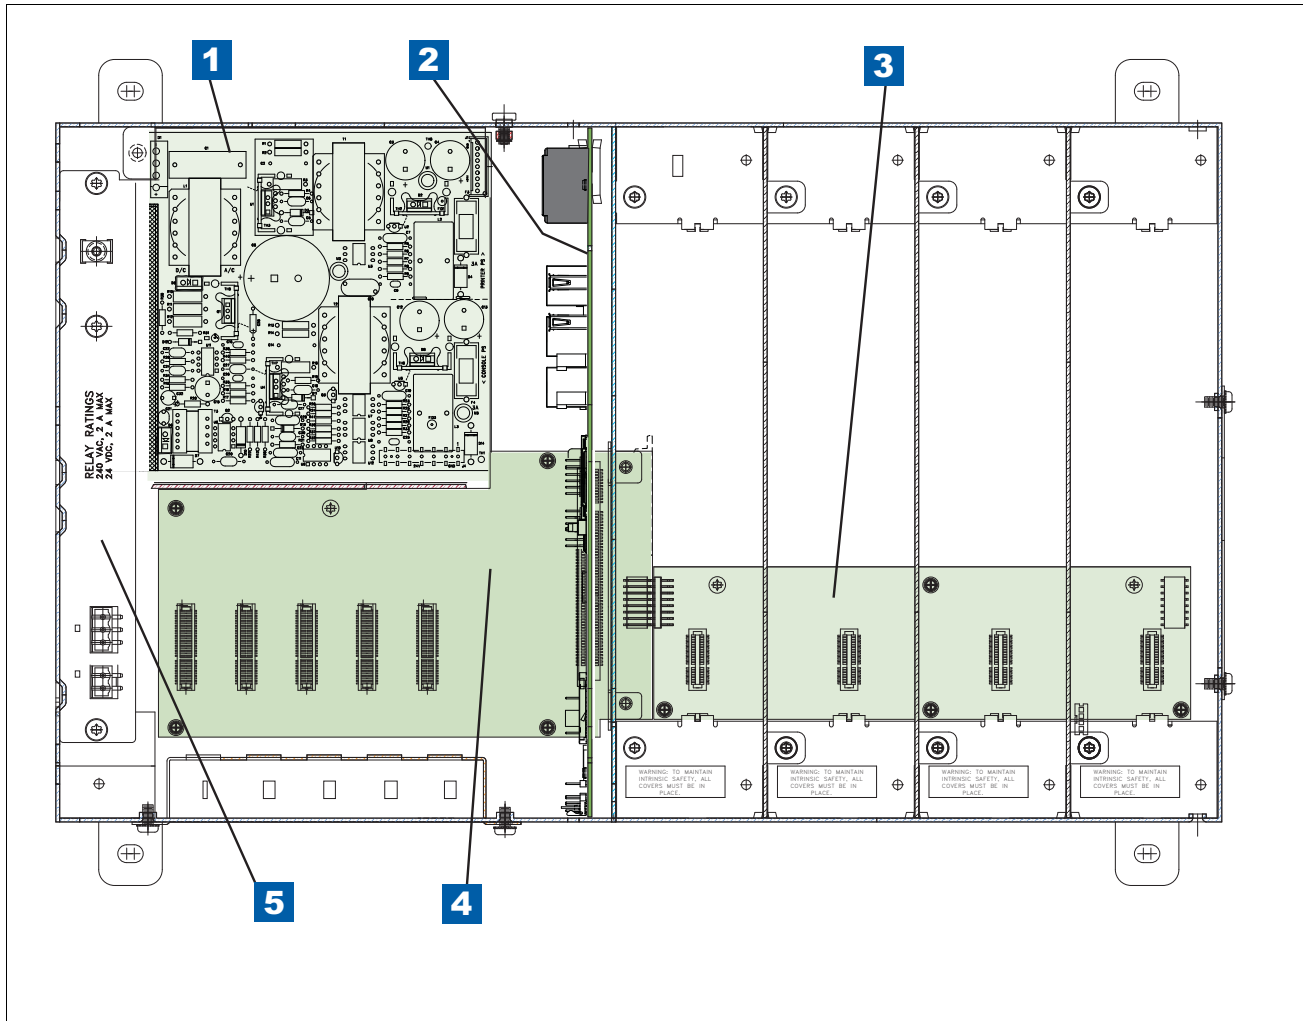
Figure 2-4. Console Board Locations (With Power Supply Protective Cover Removed)

Legend For Figure 2-4			
Item	Description	Item	Description
1	Power Supply board (access cover removed)	4	Comm Backplane board
2	CPU board	5	AC Input board assembly (access cover removed)
3	I/O Backplane board

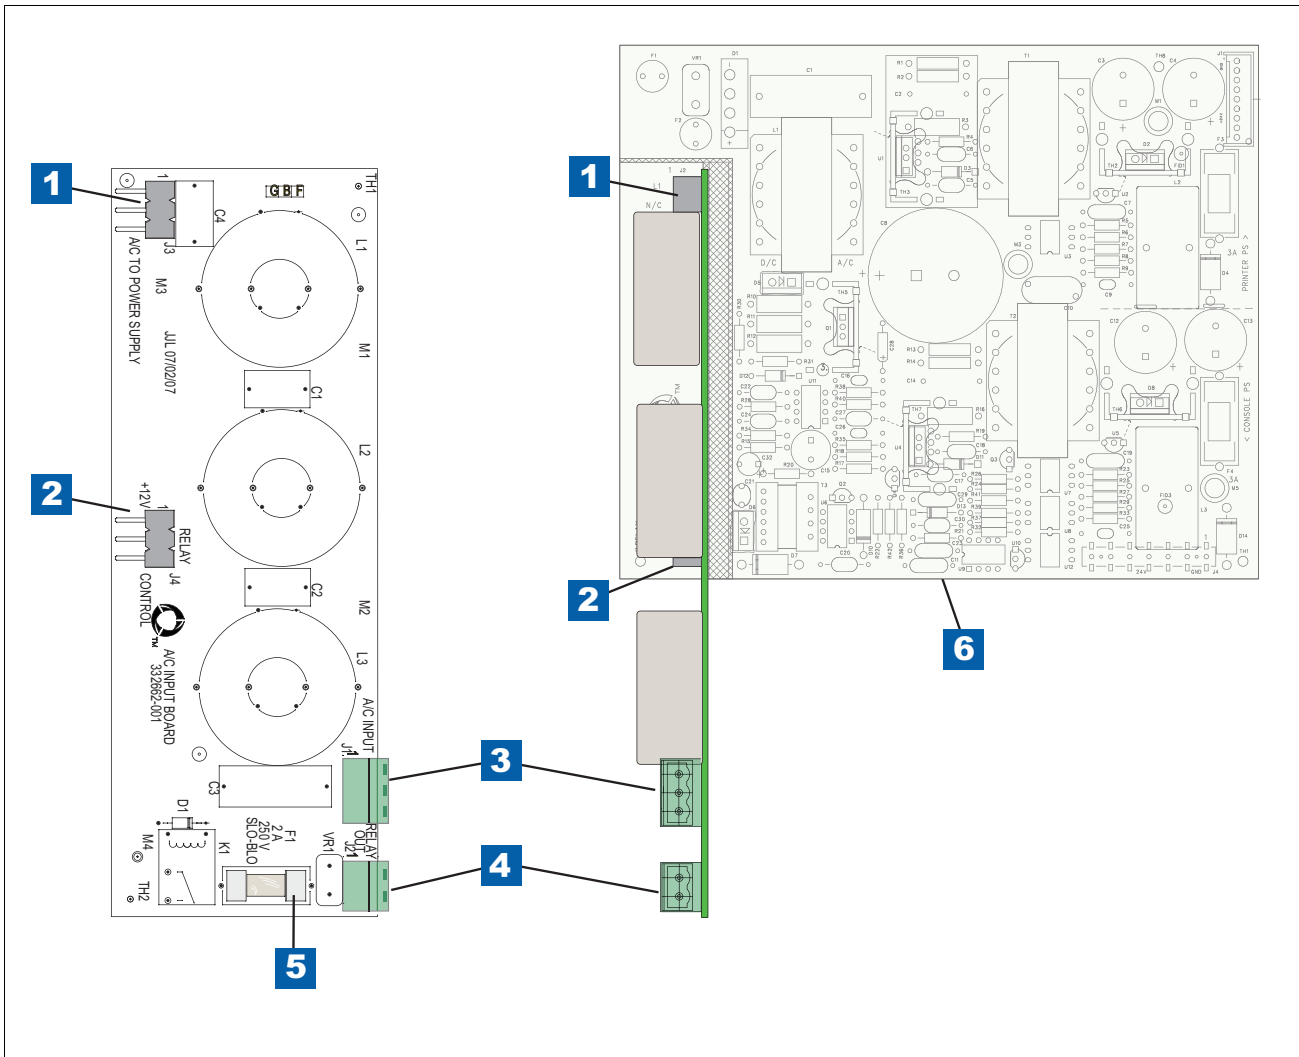
Figure 2-5. AC Input Board

Legend For Figure 2-5			
Item	Description	Item	Description
1	Console AC Input plugs into J2 on Power Supply board	5	Relay output fuse, 2A 250V Slo-Blo
2	Output relay control plugs into J3 on Power Supply board	6	AC Input board plugs into Power Supply board as shown
3	AC input power connector		
4	Output relay control connector

2. Verify that the TLS console barrier ground wire to earth ground in the power panel is a #12 AWG (or larger diameter) conductor.
3. Verify that TLS console has chassis ground at AC Input Power connector (see item 3, Figure 2-5).
4. Verify that power conduit and sensor and probe conduits enter TLS console only through preformed, designated knock-outs.
5. Verify that probe and sensor wiring and conduit meet Veeder-Root requirements (ref. manual P/N 577014-073).
6. If the system fails the intrinsic safety check, disconnect and cap the AC wires in the monitor, and disconnect and cap all probe and sensor field wires in the probe and sensor junction boxes.

Symptom	Cause	Corrective Action
<b>No display reading</b>	No AC power to monitor.	Verify power circuit breaker is switched ON Ensure power cable is properly secured to AC Input Power connector (item 3, Figure 2-5).
	AC fuse blown.	Check fuses on AC Input module and Power Supply board.
	Defective power supply.	Replace Power Supply board.
	Defective display board.	Replace display door.
<b>Printer will not print or feed paper</b>	Printer Error Alarm - Printer Traction lever in down position.	Raise printer traction lever to up position.
	Printer out of paper.	Load thermal paper (Veeder-Root Part No. 514100-328).
	Loose printer cable.	Check connections between printer and CPU board.
	Defective printer.	Replace printer door.
	Defective printer communication module.	
<b>System will not communicate via fax.</b>	Incorrect or defective interconnect cable.	Check cable between TLS and telephone jack.
	Problem with telephone line.	Call phone company.

<b>Console Does Not Power On</b>	AC Power Input connector (Item 3, Figure 2-5) is loose.	Verify AC Power Input connector is fully seated in its connector.
	The wires in the power input plug are pinched underneath the terminal's screws.	Verify each of the wires is correctly seated in each of the plug's terminal clamps. If the clamps are not opened all the way when inserting the wires into the plug, the wires can be inserted behind the clamps preventing proper contact.
	Wires to the power input plug are attached to the wrong power input terminals.	Verify correct wiring.
	Fuse missing or blown.	Check F4 fuse (Item 5 in Figure 2-6).
	Power supply board bad.	Replace Power supply board.
	AC input board bad.	Replace AC input board.
	CPU board bad.	Replace CPU board.
	Comm backplane board bad.	Replace Comm backplane board.
I/O backplane board bad.	Replace I/O backplane board.

Symptom	Cause	Corrective Action
<b>Relay Will Not Change State</b>	Setup problem - relay is not enabled.	Verify relay is enabled in the GUI. Are relays setup on TLS-450PLUS?
	Connector is not pushed all the way in.	Verify the relay plug is pushed all the way into the connector (Item 4 in Figure 2-5 on page 2-5). Verify each of the wires is correctly seated in the plug's terminal clamps. If the clamps are not opened all the way when inserting the wires into the plug, the wires can be inserted behind the clamps preventing proper contact:

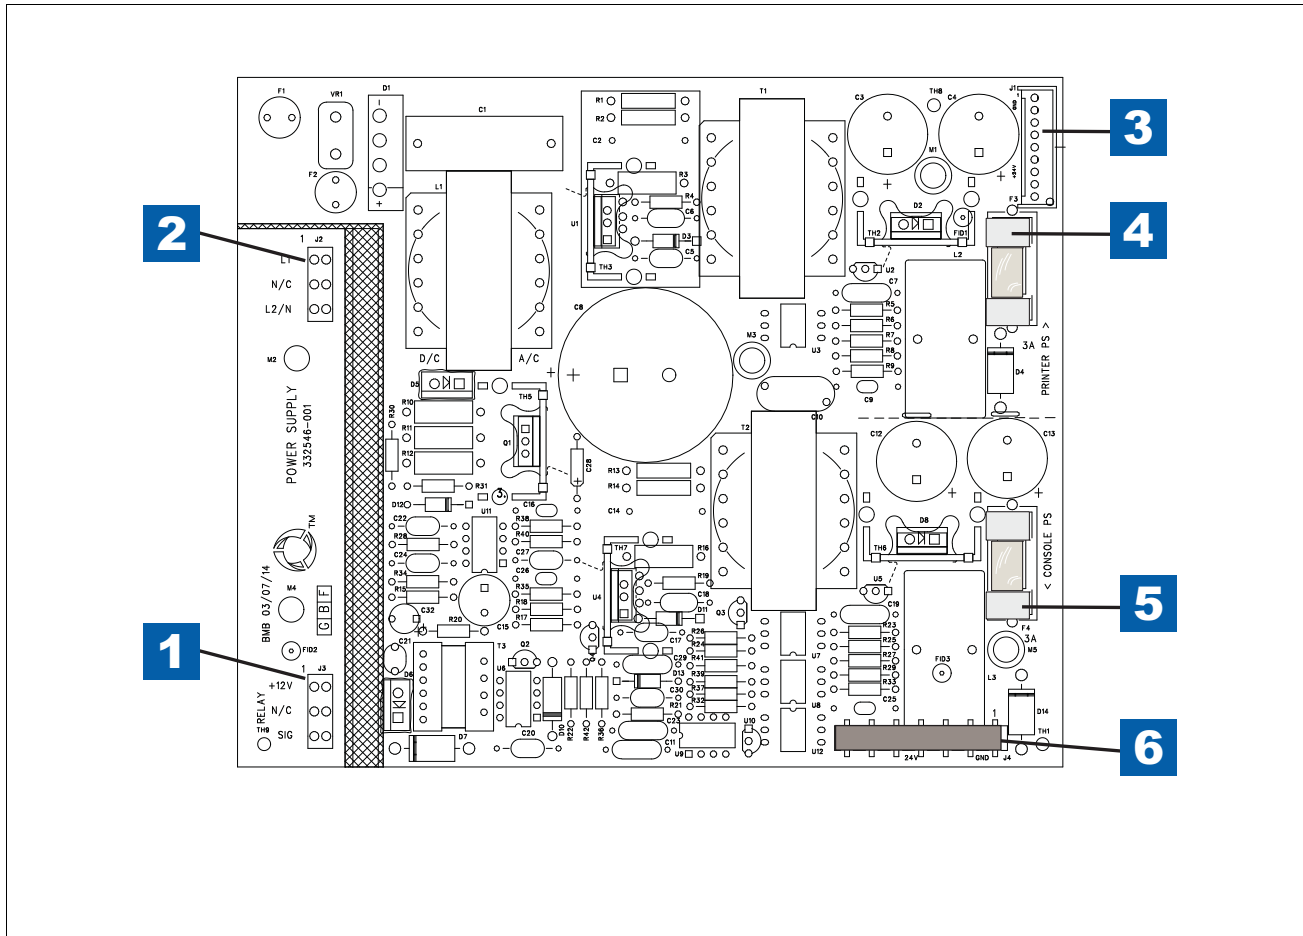
Figure 2-6. Power Supply Board

Legend For Figure 2-6			
Item	Description	Item	Description
1	Low voltage relay control connector (Relay connector on AC input board connects here)	4	Printer power supply fuse, 3A Slo-Blo
2	AC Input power connector (Line AC input connector on AC input board connects here)	5	Console power supply fuse, 3A Slo-Blo
3	Printer power connector J1	6	Power output connector (connects to Comm Backplane board)

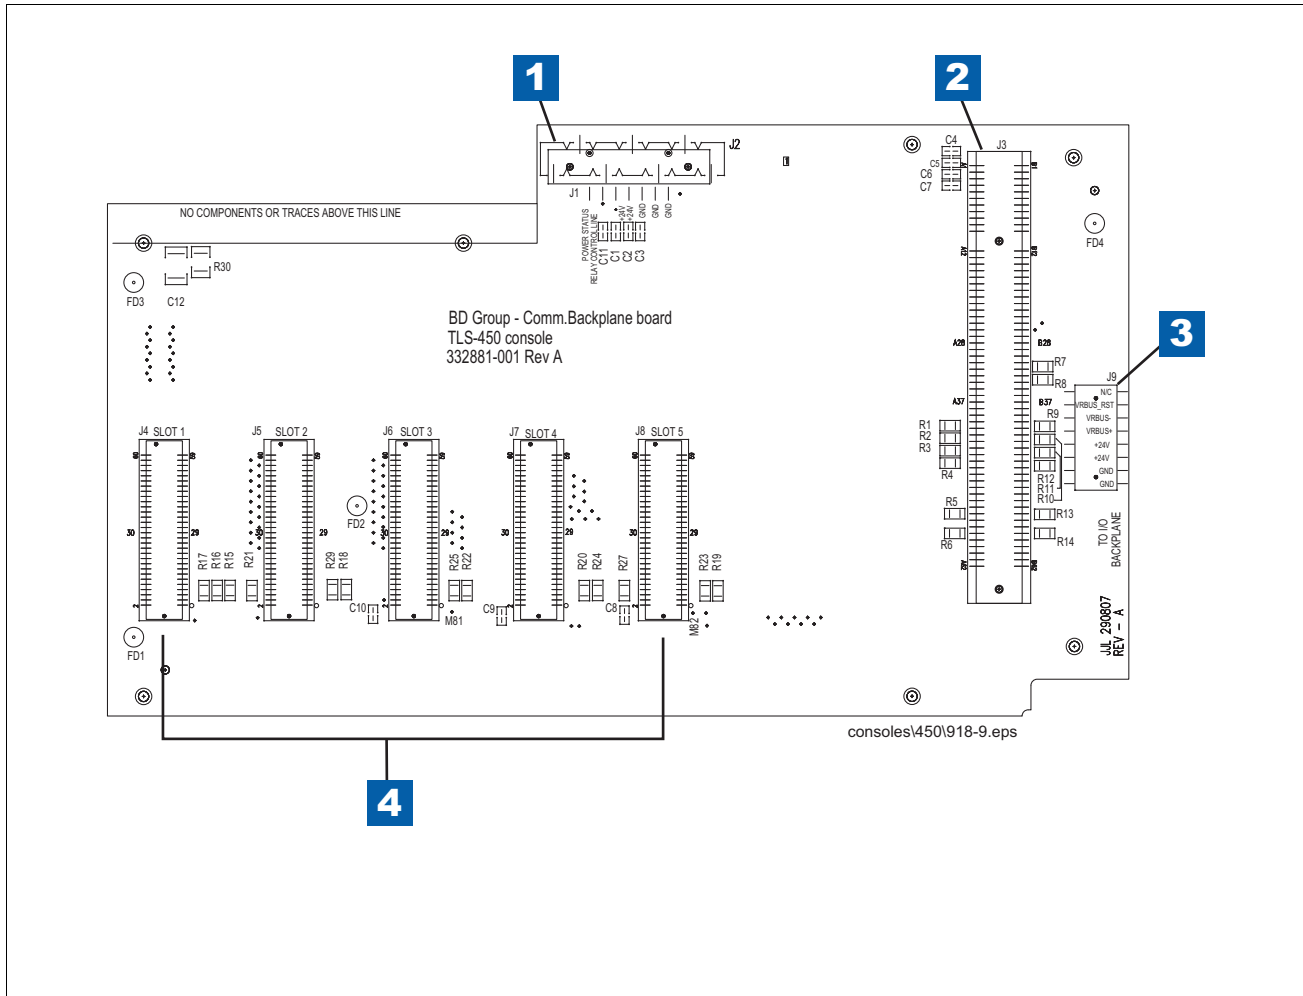
Figure 2-8. Comm Backplane Board

Legend For Figure 2-8			
Item	Description	Item	Description
1	J2 connector connects to J4 on Power Supply board	4	J4 - J8 connectors for optional Comm modules (Comm modules keyed for certain slots) See Figure 2-9 for user selectable Comm Modules. See Table 2-1 for permissible slots/ports for user selectable Comm Modules See Figure 2-10 for fixed Comm Modules.
2	J3 connector for CPU board		
3	J9 connector connects to J1 connector on I/O Backplane board

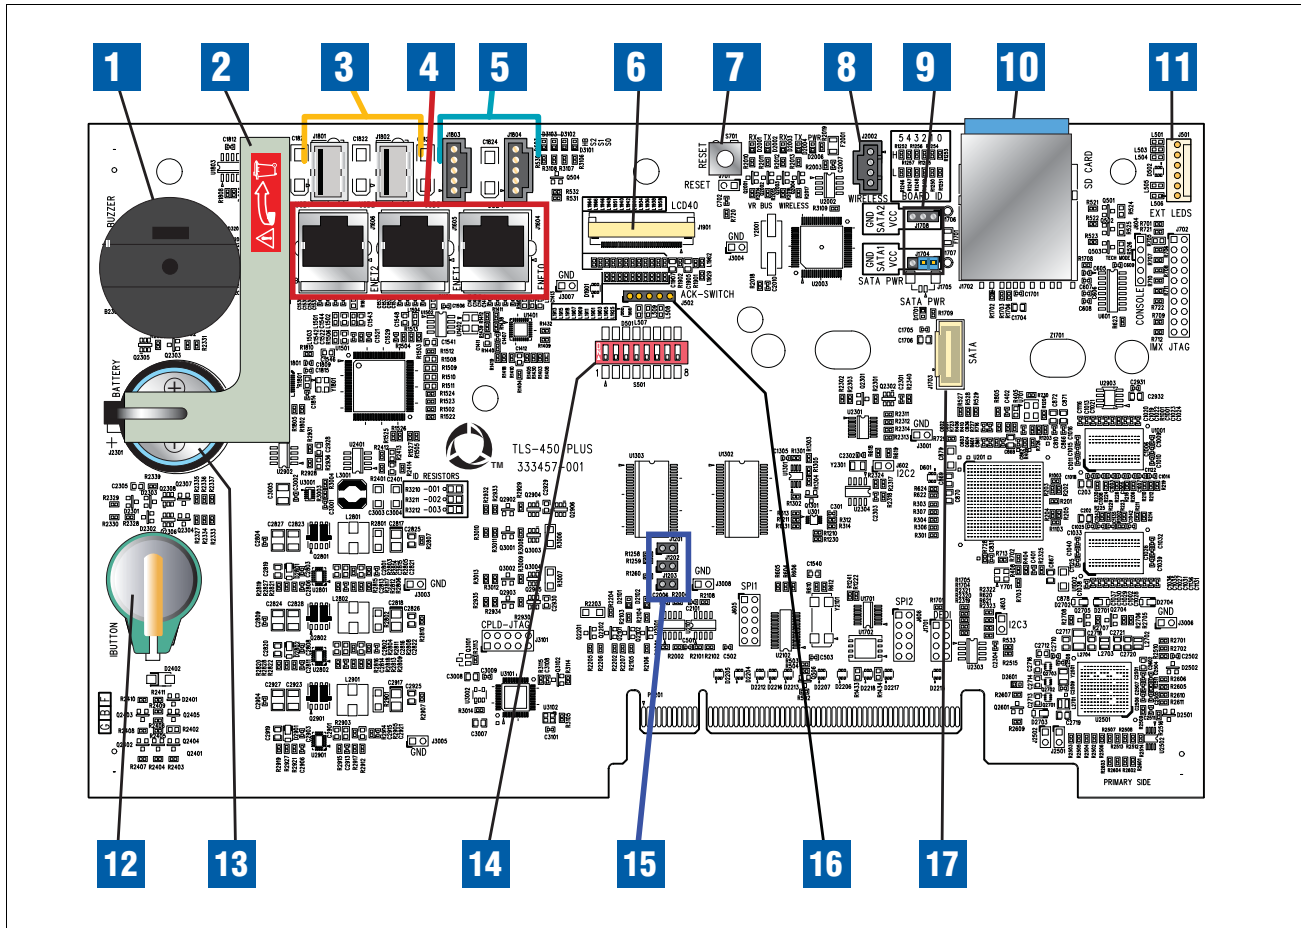
Figure 2-11. CPU Board

LEGEND			
Item	Description	Item	Description
1	Console beeper	10	SD Card (in metal enclosure)
2	Battery isolator strip - to be removed prior to startup	11	LED Backlight cable connector (optional display)
3	USB Type A connectors (2)	12	Features iButton
4	Ethernet (RJ-45) connectors (3)	13	Backup Battery
5	USB (0.1" pitch header) connectors (2)	14	Configuration DIP switches
6	Display cable connector (optional display)	15	SD card/SATA selection jumpers (J1201, J1202 & J1203)
7	Reset button	16	Acknowledge Switch panel cable connector
8	USB module - wireless cable connector	17	SD/SATA board connector
9	SATA Type Jumpers (J1704 & J1708)

Verify the Configuration DIP switches (see item 14 in Figure 2-11) are set as shown below:

Symptom	Cause	Corrective Action
<b>Incorrect Time Displayed After Console Power Loss</b>	Battery Isolator strip not removed.	Remove and discard the battery isolator strip (see Item 2 in Figure 2-11 on page 2-10).
	Battery is installed in backwards with '+' side of battery facing down in holder.	Remove the battery by gently lifting the retaining clip over the battery as you slide it to the right. Reinstall the battery with the '+' side up, by sliding it from right to left under the retaining clip until it snaps securely into the holder:

Symptom	Cause	Corrective Action
<b>"Could Not Validate IButton" Displays On GUI</b>	Features iButton is not seated properly in its holder.	<p>Check that iButton (Item 12 in Figure 2-11 on page 2-10) on the CPU board is installed correctly as shown below:</p>

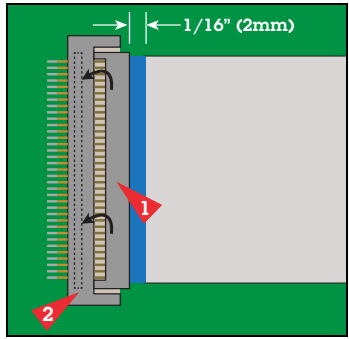
<p>3. If the cable appears loose or out of the connector, rotate the locking member of the cable connector (1 pointer) up 90° from the connector's fixed base (2 pointer). Reseat the cable end into the connector as far as it will go and then push the locking member down onto the connector snapping it in place.</p>
	Bad SD card.	Replace SD card.
	Bad CPU board.	Replace CPU board.
<b>Acknowledge (Ack) Switch Not Working Properly</b>	The Ack cable plug is loose or not plugged in Ack connector.	Reseat cable connector.

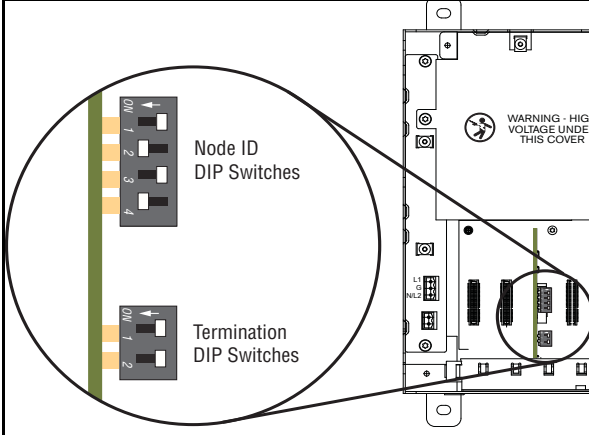
Symptom	Cause	Corrective Action																																																																																																					
<b>IFSF Communication Not Working - (cont'd.)</b>	Node ID Setting Incorrect	<p>Get the correct Node ID setting from the site's LON administrator and verify that the correct Node ID has been entered:</p> <ol style="list-style-type: none"> <li>Shut off power to the console.</li> <li>Remove the two T15 Torx screws securing the left door of the console (item 2 in Figure 2-1 on page 2-1) and open the left door.</li> <li>Locate the Node ID and Termination DIP switches on the IFSF LON module (comm slots 1,2, or 3):</li> </ol>

<ol style="list-style-type: none"> <li>The Termination DIP switches are set in the NO TERMINATION or all the way to the right in the image above).</li> <li>The Node ID DIP switches are set to a value supplied by the Site IFSF LON Administrator. LON Node Address is subnet 9, Node X, where X is selected using DIP switches 1-4 using the legend below:</li> </ol>

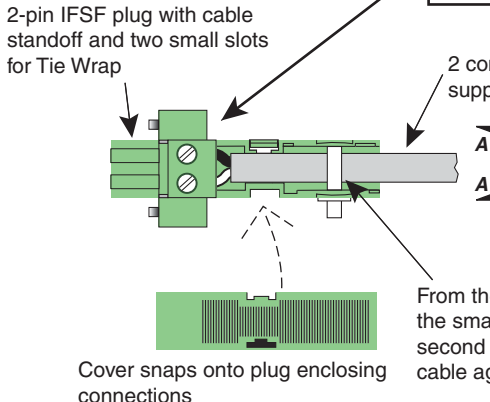
Symptom	Cause	Corrective Action
<p><b>IFSF Communication Not Working - (cont'd.)</b></p>	<p>Bad cable connecting ATG to LON network</p>	<p>Verify the external input plug is pushed all the way into the connector on the IFSF module. Verify if wires are loose or broken. If necessary, replace cable. The IFSF cable's plug will have to be assembled in the field as shown below:</p>

2-pin IFSF plug with cable standoff and two small slots for Tie Wrap

2 conductor LON cable supplied by customer

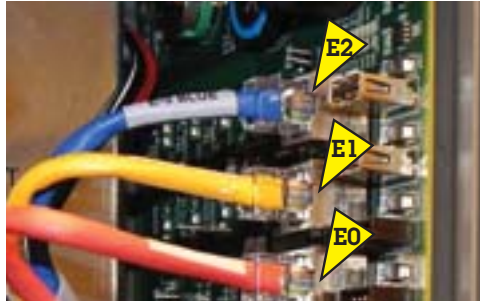
Symptom	Cause	Corrective Action
<b>No Connection To Ethernet Port</b>	Cable is plugged into the wrong port.	Verify Ethernet cables are plugged into correct port(s) on the bottom of the console (ref. Slot 4 in Figure 2-10 on page 2-9 ).
	Cable is not properly connected to CPU board.	Open Printer door. Verify that the Slot 4 Ethernet Interface module cables are properly connected to the CPU board connectors:

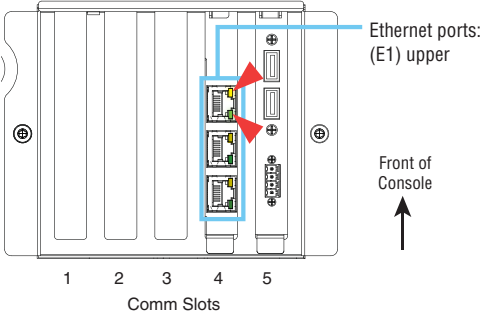
Ethernet communication settings, such as, IP Address type, IP Address, etc.	<ol style="list-style-type: none"> <li>1. Verify Ethernet communication settings are correct.</li> <li>2. Check if Ethernet port's Link and Activities LEDs are flashing:

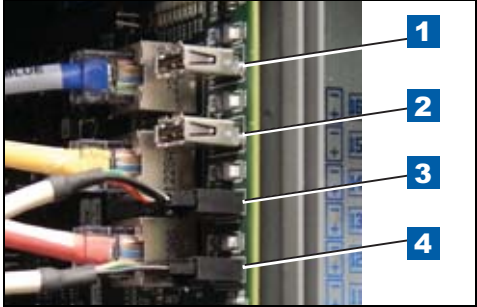
Symptom	Cause	Corrective Action
<b>USB communication not working</b>	Cable(s) not properly plugged into port on USB module.	Verify cables are plugged into moduled properly (ref. Slot 5 in Figure 2-10).
	Cable(s) not properly plugged into connectors on CPU board.	Open Printer door. Verify that the Slot 5 USB module cables are properly connected to the CPU board USB connectors 3 and 4:

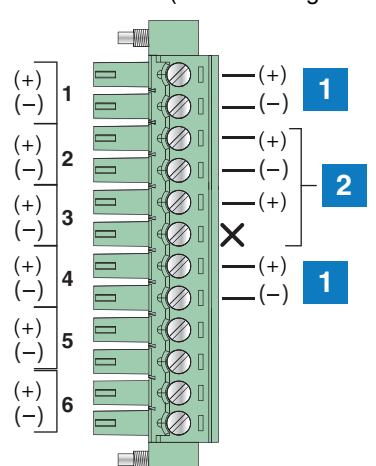
Symptom	Cause	Corrective Action
<b>Sensor Connected To TLS-450PLUS But No Sensor Address Under Devices Menu</b>	Sensor wires were connected while the console was ON.	Re-boot console.
	Sensor wiring installed incorrectly.	<p>1. Open the Display door.</p> <p>2. Polarity may be required for this device. Locate the questionable sensor's input wiring connections at the USM connector.</p> <p>If polarity required, verify the two wires are connected with white to + terminal and black to – terminal. (item 1 in diagram below)</p> <p>If three wire sensor, verify the three wires are connected as shown below (item 2 in diagram below):</p>

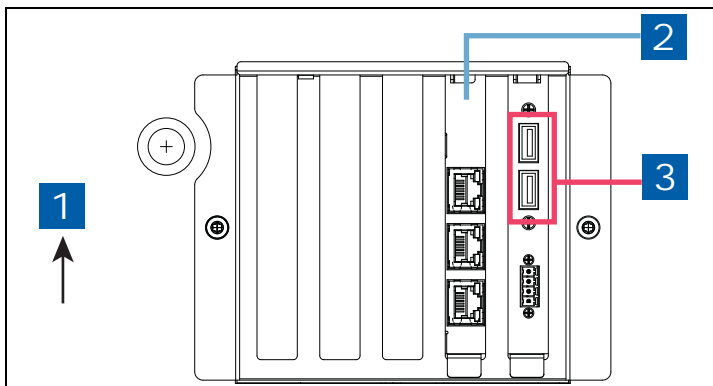
Figure 7-1. USB Board - USB Ports

1. Front of console
2. Ethernet Interface Module
3. USB Ports on USB Module

1. Beneath the left side of the 450 Plus console, locate the USB Module and insert the V-R Backup thumb drive, minimum 4 GB, (P/N 332970-004) into one of the external USB ports on the USB module, P/N 333477-001 (see item 3 in Figure 7-1).

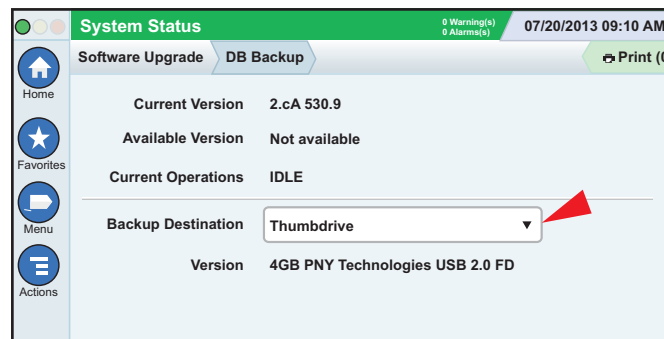
Figure 7-2. DB Backup Screen

2. From the Home Screen touch **Menu > Software Upgrade > DB Backup** to view the Database Backup Screen (see Figure 7-2). Touch the down arrow in the Backup Destination field to select the Backup thumb drive inserted in Step 1, then follow the on-screen instructions to backup TLS-450PLUS console data.

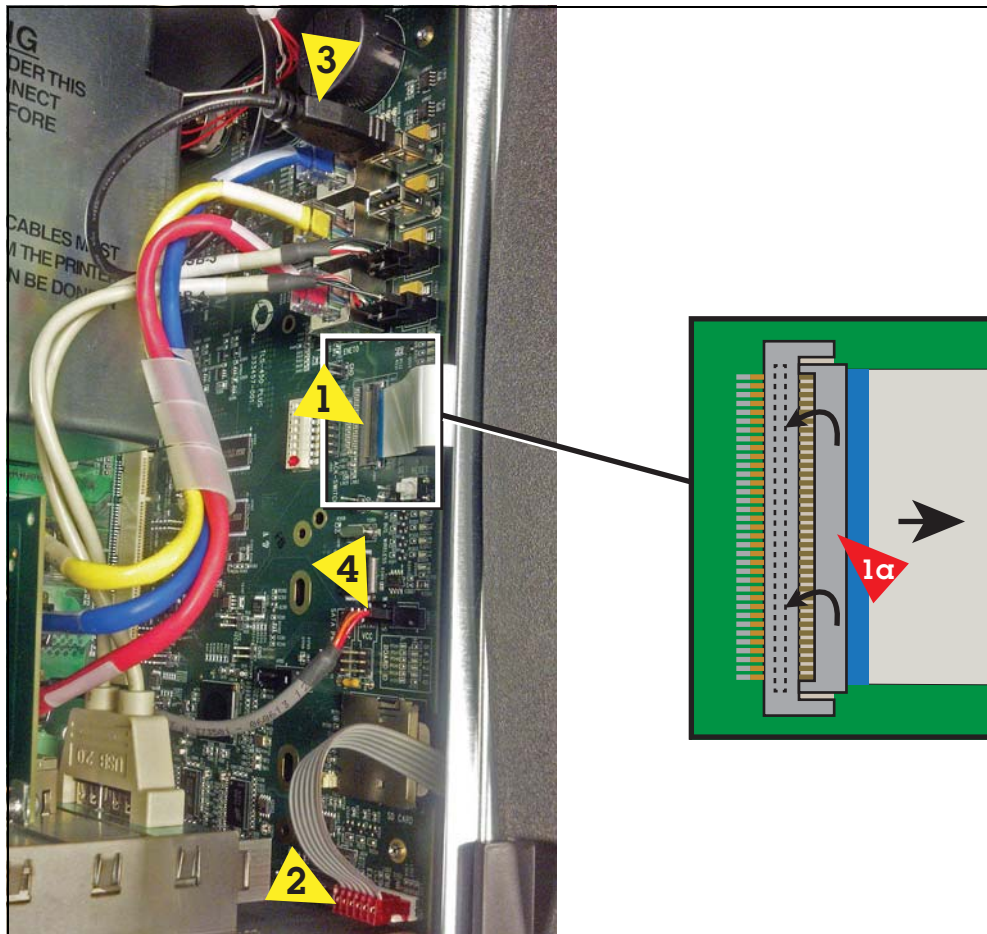
Figure 7-3. Remove Optional Printer And Display Cables From CPU Board

For the optional Display door, remove the Display cable (pointer 1 in Figure 7-3) from the CPU board connector. Rotate the locking member of the cable's Display connector (1a pointer) up 90° from the connector's fixed base and slide cable end out.

3. Remove the LED Back light cable (pointer 2) from CPU board connector (see Figure 7-3).

8. Remove the Printer cable (Pointer 3 Figure 7-3) and the Wireless cable (pointer 4 in Figure 7-3) from the CPU board connector.
9. Locate the three retention snap pins along the front edge of the CPU board. Position your forefinger beneath one of the pins and press up releasing the CPU board from the snap pin. Repeat at each of the remaining two retention pins.
10. Tilt the board a little away from the bulkhead and grasping the edge of the board pull out firmly to remove the board from its backplane board connector. Once the CPU board is free from the connector, slowly remove the board from the console.

3. If a printer is installed, remove the printer's USB cable (pointer 3 in Figure 7-3) from the top USB connector (USB 1).
4. Loosen the T15 ground clamp screw securing the ground wire at the top of the Printer door and slide it free of the clamp (see Figure 7-12).

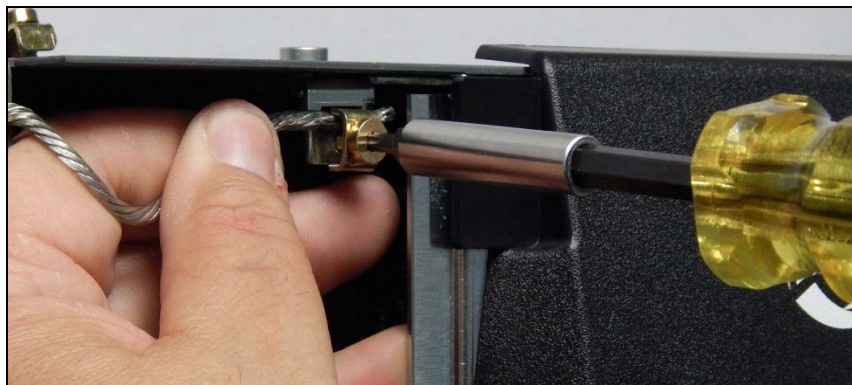
**Figure 7-4. Remove Ground Wire From Ack Switch/Display Door**

4. Remove the Ground wire at the top of the door (see Figure 7-4).

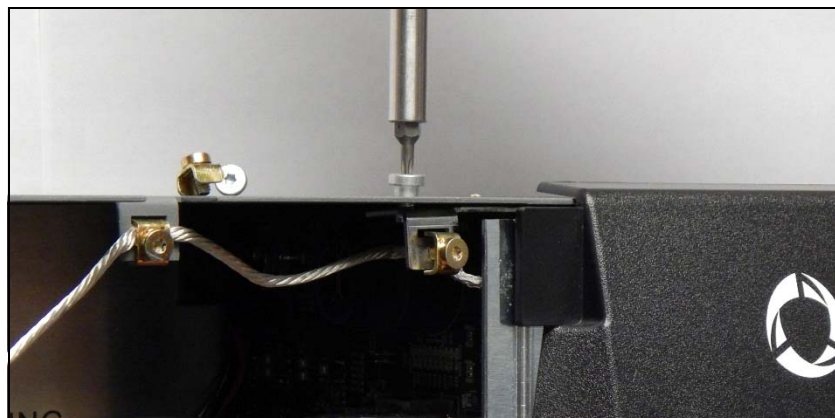
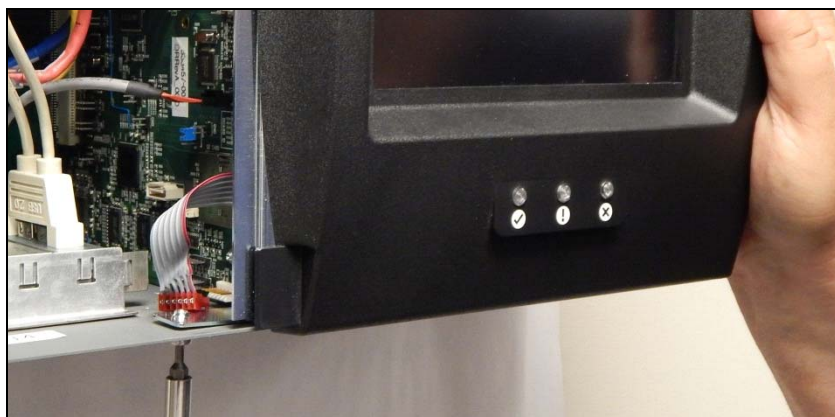
**Figure 7-5. Remove Top And Bottom Optional Display Door Hinge Screws**

5. Remove the TLS-450PLUS Ack Switch Panel/Display door by removing the top and bottom hinge shoulder screws (see Figure 7-5).

6. Remove the TLS-450PLUS Printer door by removing the top and bottom hinge shoulder T15 screws (similar to the Ack Switch Panel/Display Door shoulder screws Figure 7-5).

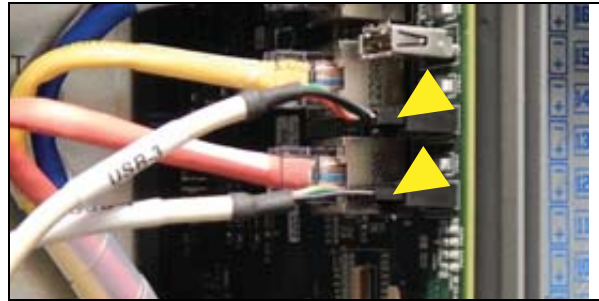
Figure 7-6. Remove USB Module Cables From CPU Board

6. Remove the USB module cables from the CPU board (two USB cables - top pointers; Wireless cable - bottom pointer) (see Figure 7-6).

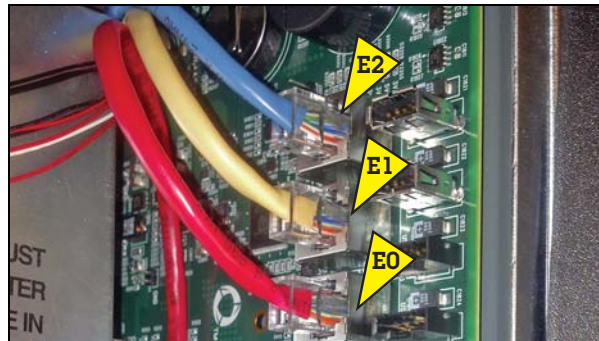
Figure 7-7. Remove Ethernet Module Cables From CPU Board

7. Remove the three Ethernet Module cables E2 (blue), E1 (yellow) and E0 (red) from the CPU board (see Figure 7-7).

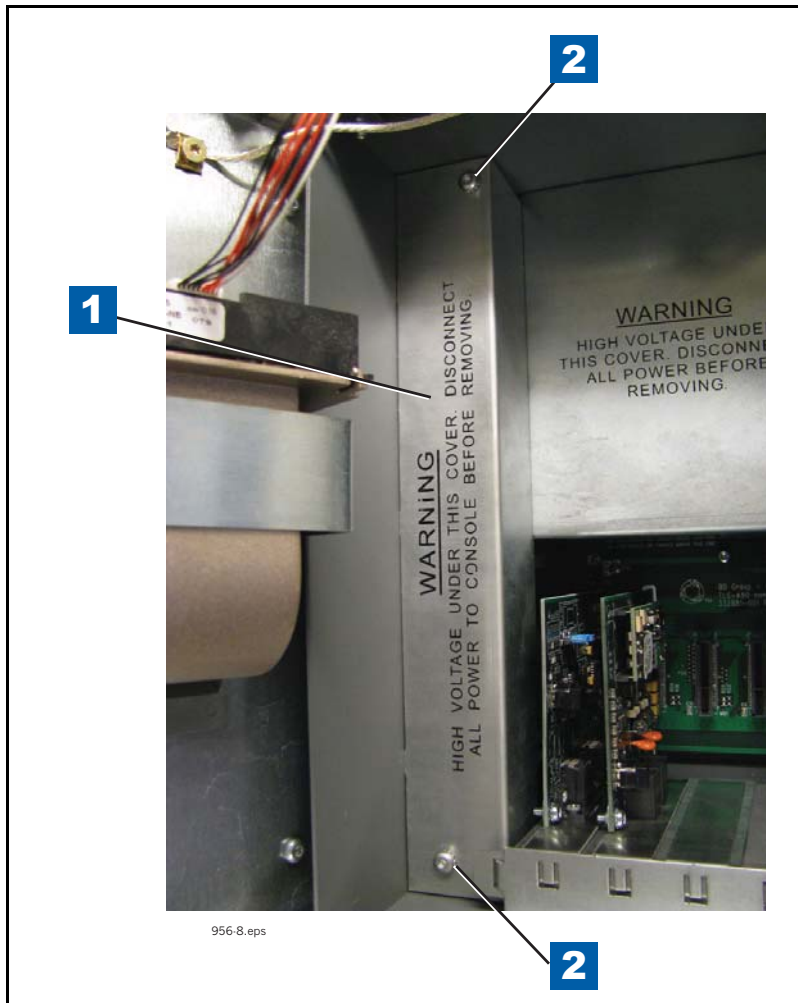
Figure 7-8. Remove AC Channel Cover

1. Perform all of the Steps in the section entitled "Before Turning Off Power" on page 7-2.
2. Open the console doors as described in Step 1 of the section entitled "Removing The Ack Switch Panel/ Display (Right) Door And CPU Board" on page 7-3.
3. Remove the two T15 screws from the AC Channel cover and put the cover and screws aside (see Figure 7-8).

Legend For Figure 7-8			
Item	Description	Item	Description
1	AC Channel cover.	2	T15 screws (2).

15. Notice that there are two male connectors on the bottom of the AC Input Filter board that plug into two female connectors on the Power Supply board. With the handle (item 3 of Figure 7-9) of the AC Input Filter against the left side of the console housing, line up the two AC Input Filter bottom connectors over the two female connectors (items 4 and 5 in Figure 7-10) on the Power Supply board and push down on the AC Input Filter until the connectors are firmly seated.
16. Place the Power Supply shield (item 2 in Figure 7-9) over the Power Supply board and lower it down onto its two retention pins (see item 2 in Figure 7-11) and snap it into place.
17. Install the three T15 screws in the AC Input Filter (see item 1 in Figure 7-9).
18. Replace the AC Channel cover and install the two T15 screws (see Figure 7-8).

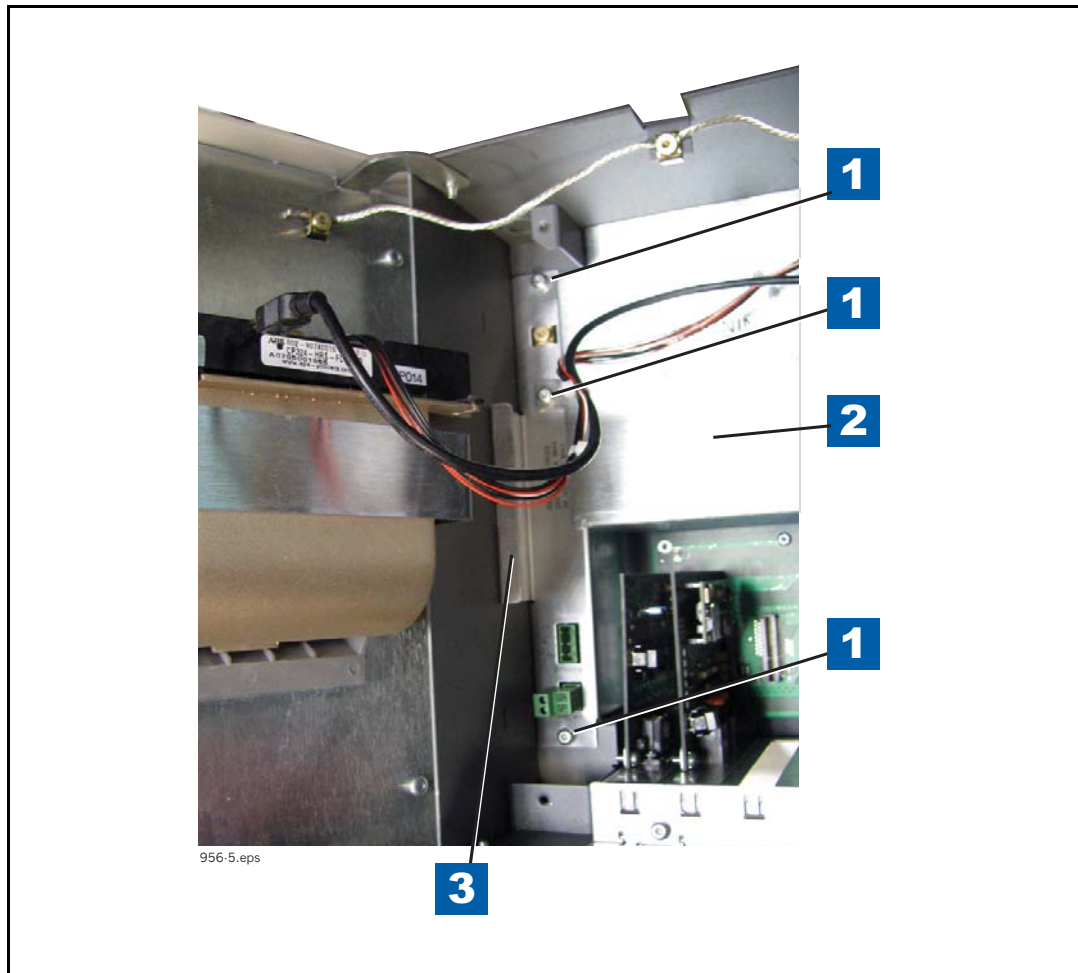
Figure 7-9. Removing AC Input Filter

4. Remove the three T15 screws in the AC Input Filter (item 1 in Figure 7-9).
5. Lift the Power Supply shield up to disengage the two retention snap pins in its right side flange and remove it from the console (item 2 in Figure 7-11).
6. Grasp the AC Input Filter handle (see item 3 in Figure 7-9) and slowly pull up and away from the Power Supply board until the two AC Input Filter plugs disconnect from the Power Supply board connectors. Lift the AC Input Filter out of the console. Remove the two T-15 screws that secure the AC Input board to the AC input board bracket. Place fingers under the AC Input board near each of the two retention pins and lift the board up until it is free of the pins.

Legend For Figure 7-9			
Item	Description	Item	Description
1	T15 screws (the middle one secures the Power Supply shield to the AC Input Filter bracket)	3	AC Input Filter handle
2	Power Supply shield

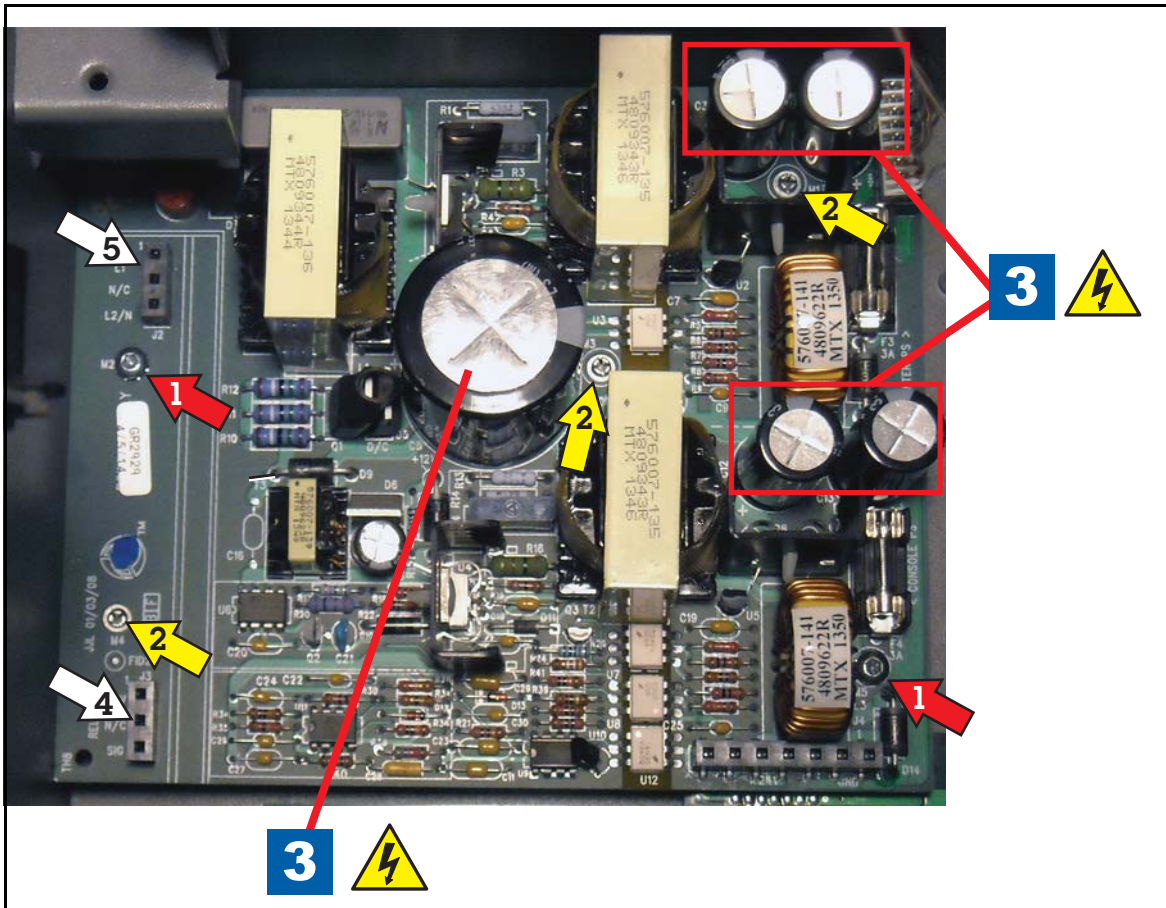
Figure 7-10. Removing Power Supply Board

7. Remove the two T15 screws (item 1 in Figure 7-10) that secure the Power Supply board to the console housing.
8. Place a finger under the edges of the Power Supply board near the upper right and lower left edges of the board and lift the board up until it is free of the three snap pins (item 2 in Figure 7-10).

**WARNING! Shock hazard. Do not touch underside of Power Supply board beneath the five capacitors (identified by item 3 in Figure 7-10).**

10. Lift the board out of the console by its edges since there is still undischarged high voltage in the item 3 capacitors.

Legend For Figure 7-10			
Item	Description	Item	Description
1	Power Supply Board T15 securing screws	3	Power Supply Board capacitor warning.
2	Power Supply Board retention snap pins

11. Get the new Power Supply board and lower it into the console.
12. Attach the printer power supply cable to its connector (J1) on the upper right corner of the replacement Power Supply board.
13. Line up the three holes in the Power Supply board (see item 2 in Figure 7-10) with the three retention pins in the back of the console housing and push the board down until the pins snap into position.
14. Install the two T15 screws (item 1 in Figure 7-10) and tighten them.
