# TLS-450<sup>PLUS</sup> Consoles

## Troubleshooting Guide

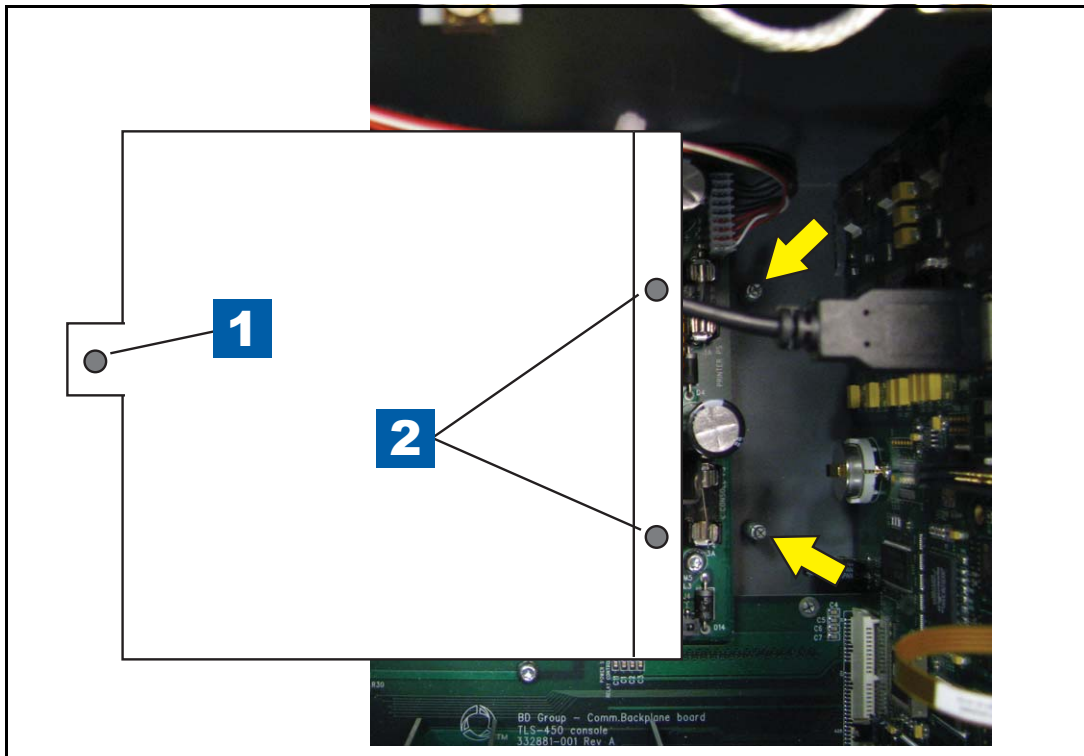
Figure 7-11. Replacing Power Supply shield over Power Supply board

Legend For Figure 7-11			
Item	Description	Item	Description
1	T15 screws	2	Board retention snap pins

4. Remove the three T15 screws in the AC Input Filter (item 1 in Figure 7-9).
5. Lift the Power Supply shield up to disengage the two retention snap pins in its right side flange and remove it from the console (item 2 in Figure 7-11).
6. Grasp the AC Input Filter handle (see item 3 in Figure 7-9) and slowly pull up and away from the Power Supply board until the two AC Input Filter plugs disconnect from the Power Supply board connectors. Lift the AC Input Filter out of the console. Remove the two T-15 screws that secure the AC Input board to the AC input board bracket. Place fingers under the AC Input board near each of the two retention pins and lift the board up until it is free of the pins.

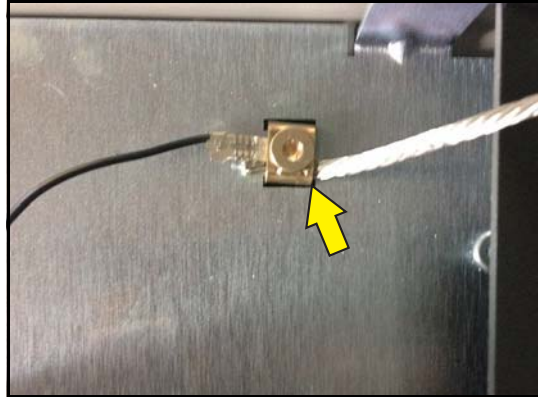
Figure 7-12. Removing Printer Door Ground Wire

3. If a printer is installed, remove the printer's USB cable (pointer 3 in Figure 7-3) from the top USB connector (USB 1).
4. Loosen the T15 ground clamp screw securing the ground wire at the top of the Printer door and slide it free of the clamp (see Figure 7-12).

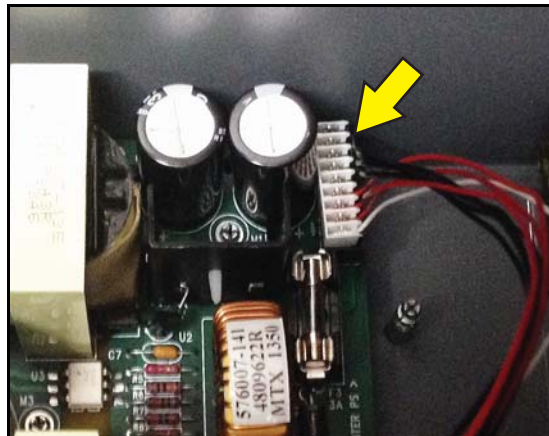
Figure 7-13. Removing Printer Door Ground Wire

5. If a printer is installed, unplug the Printer power cable plug from the Power Supply board connector. (see Figure 7-13).

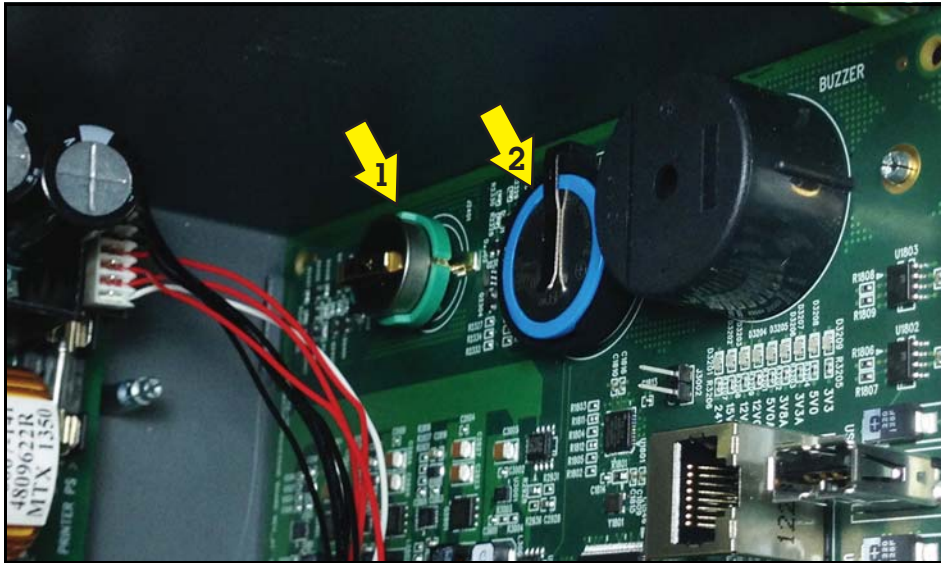
Figure 7-14. Locating Features iButton And Backup Battery

1. Perform all of the Steps in the section entitled "Before Turning Off Power" on page 7-2.
2. Open the right and left console doors as described in Step 1 of the section entitled "Removing The Ack Switch Panel/Display (Right) Door And CPU Board" on page 7-3.
3. Locate the backup battery at the top of the CPU board (see pointer 2 in Figure 7-14).

Legend For Figure 7-14			
Item	Description	Item	Description
1	Features iButton	2	Backup Battery

4. Holding the CPU board by its edges, place it on a clean surface. Locate the Features iButton at the top of the CPU board (see pointer 1 in Figure 7-14).
5. Remove the iButton by gently lifting the retaining clip over the iButton as you slide it out of its holder.
6. When inserting the iButton make sure the flanged side is up as it is slid into its holder:

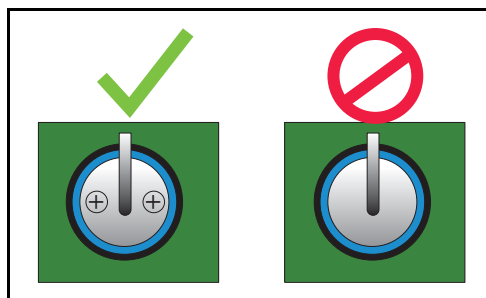
- Remove the battery by gently lifting the retaining clip over the battery as you slide it down out of its holder. Reinstall the battery with the '+' side up, by sliding it up under the retaining clip until it snaps securely into the holder:

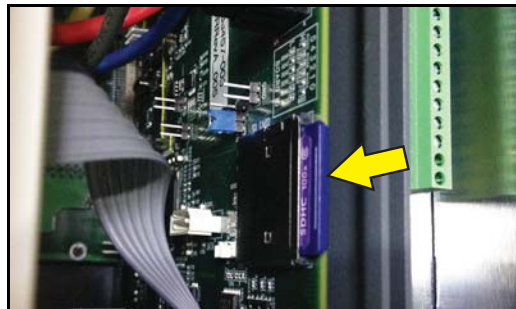
1. Perform all of the Steps in the section entitled “Before Turning Off Power” on page 7-2.
2. Open the console doors as described in Step 1 of the section entitled “Removing The Ack Switch Panel/ Display (Right) Door And CPU Board” on page 7-3.
3. Locate the SD card on the lower front edge of the CPU board:

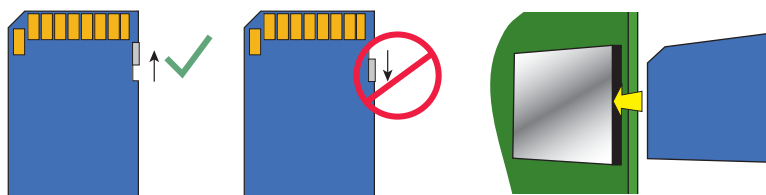
4. Remove the SD Card by pushing in on card then quickly releasing it, letting it spring free of its enclosure's latch then slide it out.
5. Perform a database restore procedure (Menu>Software Upgrade>DB Restore) to reload system data into a new SD card.
6. Before replacing the SD Card, always check the position of the write protect slide on the side of the SD Card, making sure it is in the position shown below and then reinsert it in its enclosure until it clicks into the enclosure's latch:

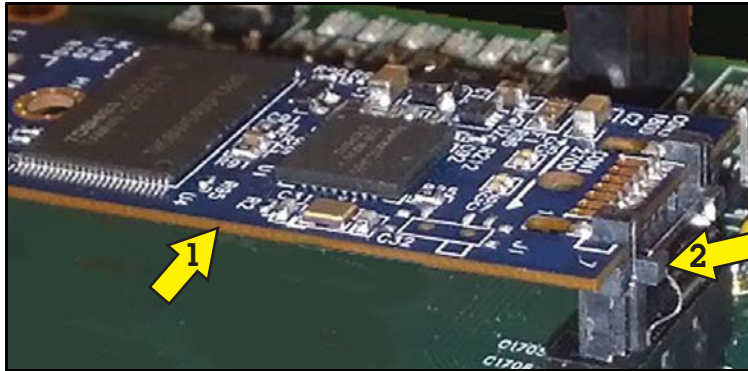
1. Perform all of the Steps in the section entitled “Before Turning Off Power” on page 7-2.
2. Open the console doors as described in Step 1 of the section entitled “Removing The Ack Switch Panel/ Display (Right) Door And CPU Board” on page 7-3.
3. Locate the small SATA drive board in the middle of the CPU board (pointer 1 below):

*Note: SATA drive may appear slightly different than version shown.*

4. Wearing a static avoidance wrist strap grounded to the console, push in on the small button (pointer 2 above) to release the plug latch and lift the small SATA drive board from the connector.
5. Handle the SATA drive by its edges and avoid touching components on the board. To reinstall push the SATA drive board plug into the CPU connector until the plug latch snaps into place.
6. Perform a database restore procedure (Menu>Software Upgrade>DB Restore) to reload system data into a new SATA drive.
